STATE OF CALIFORNIA
DEPARTMENT OF PUBLIC WORKS
DIVISION OF HIGHWAYS

ENVIRONMENTAL INFLUENCE
ON THE CORROSION OF REINFORCING STEEL
IN CONCRETE BRIDGE SUBSTRUCTURES

at the 42nd Annual Meeting
of the Highway Research Board
Washington, D.C.

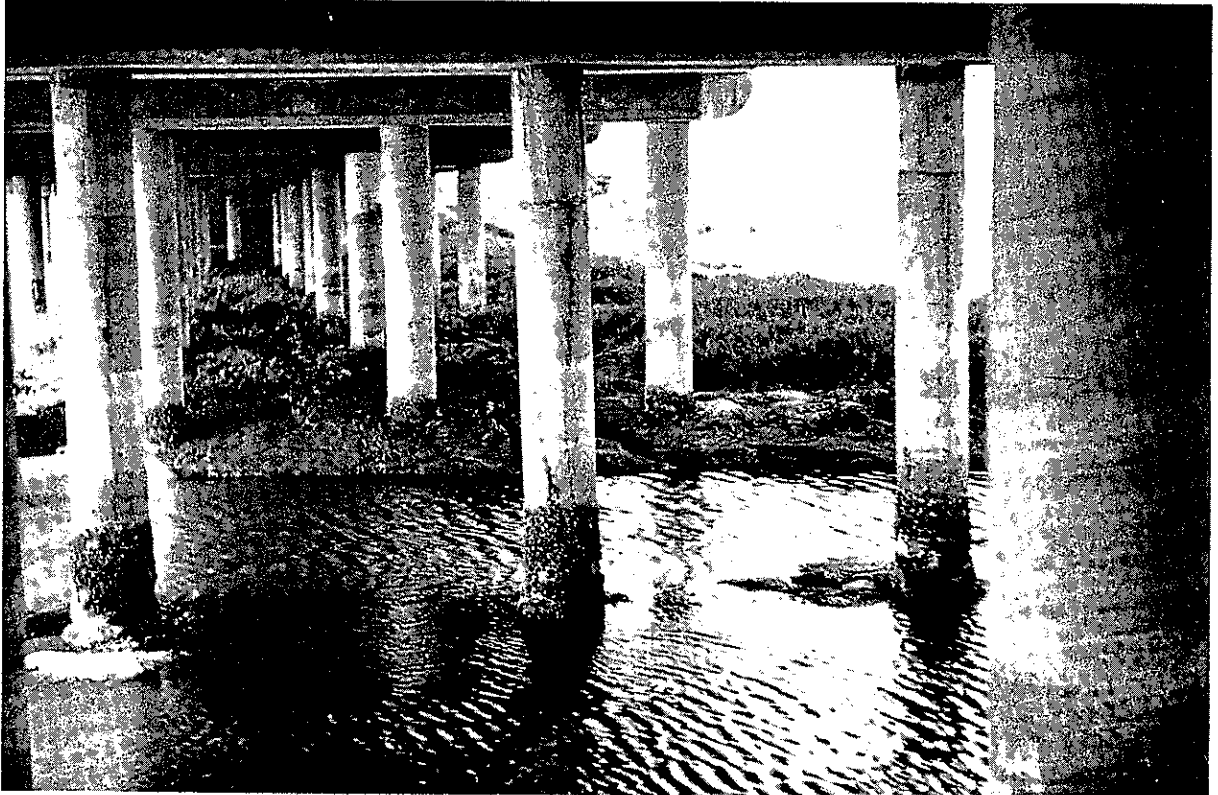
Photograph 1

Vertical concrete cracking of 10 year old reinforced concrete
bridge piles in tidal water near San Diego, California.
Photo taken in 1962.

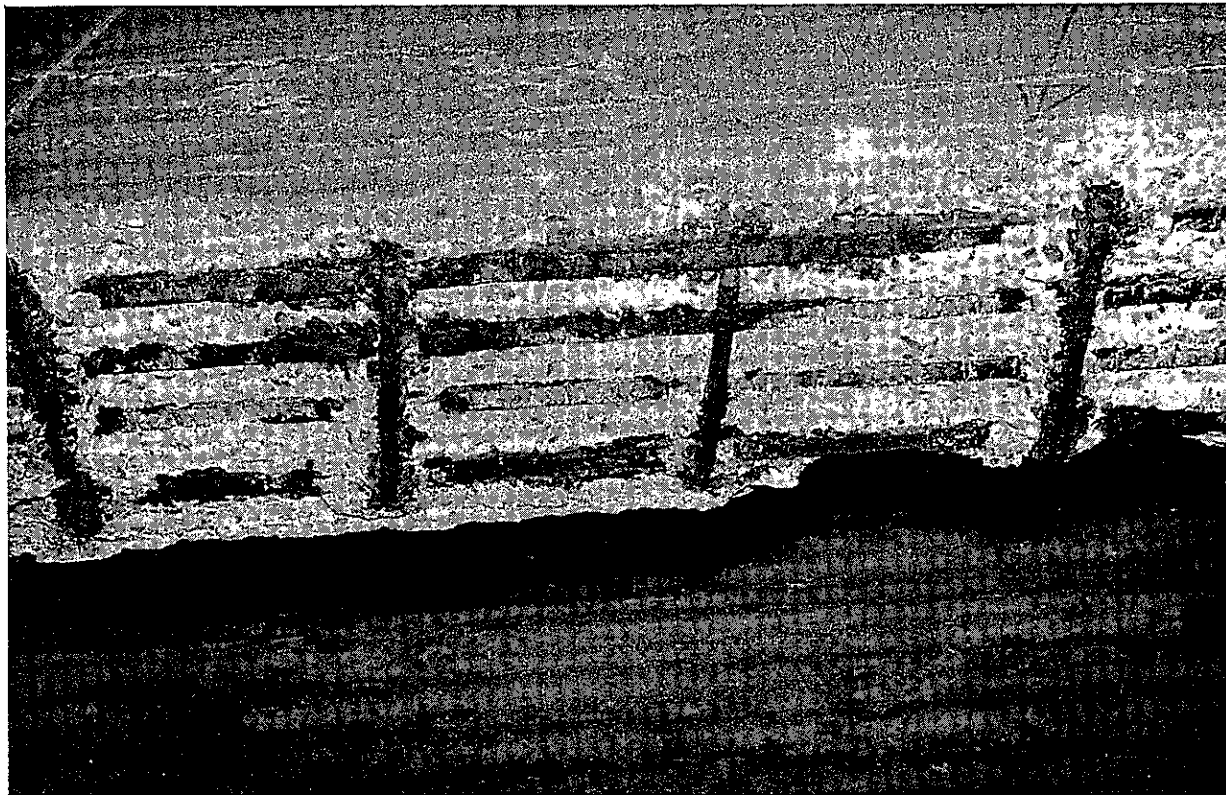
Photograph 2

Spalling of concrete in beam caused by the corrosion of
reinforcing steel, San Francisco-Oakland Bay Bridge.
Photo taken in 1962.
